INDOOR AIR QUALITY ASSESSMENT

**Canton Public Library
378 Washington Street
Canton, Massachusetts**

Prepared by:
Massachusetts Department of Public Health
Center for Environmental Health
Bureau of Environmental Health Assessment
Emergency Response/Indoor Air Quality Program
May 2004

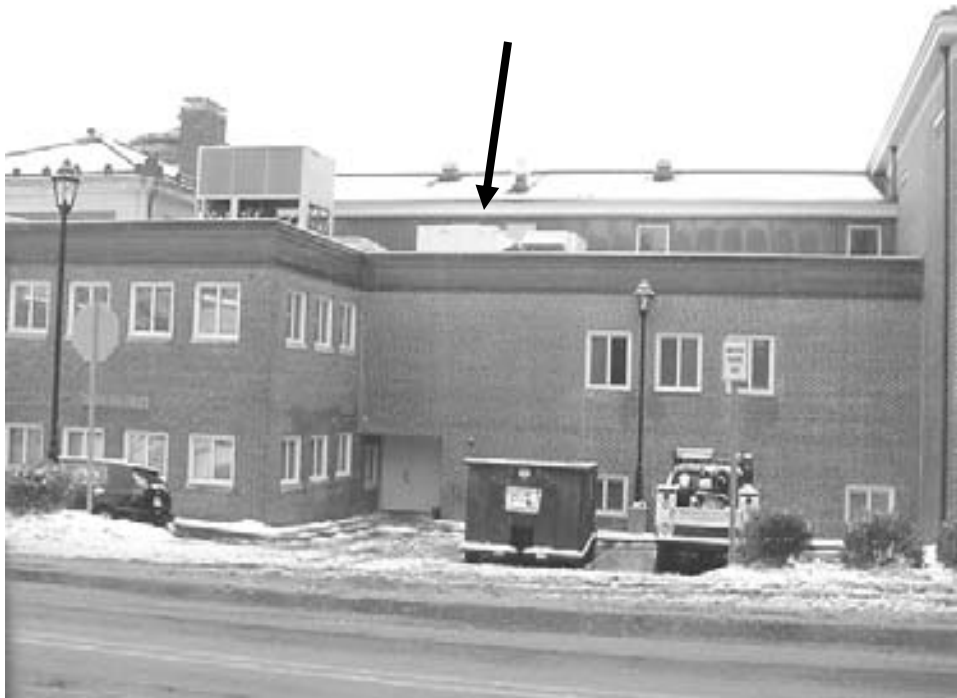
Picture 1

The CPL is a two-story structure with a finished, basement/ground floor. The CPL was constructed in 1903 and renovated in 2003. During the 2003 renovations, a new heating, ventilating and air-conditioning (HVAC) system was installed. As reported by CPL staff, a coil within an air-handling unit (AHU) froze during the extreme cold weather experienced in New England in January, 2004 (Picture 1). As a result of the coil bursting, water saturated the interior of the building on the first and ground floors. At the time of the assessment, the CPL was undergoing an extensive remediation effort to dry and/or remove water contaminated building components.

AHU with Frozen Coil above Water Damaged First Floor Area

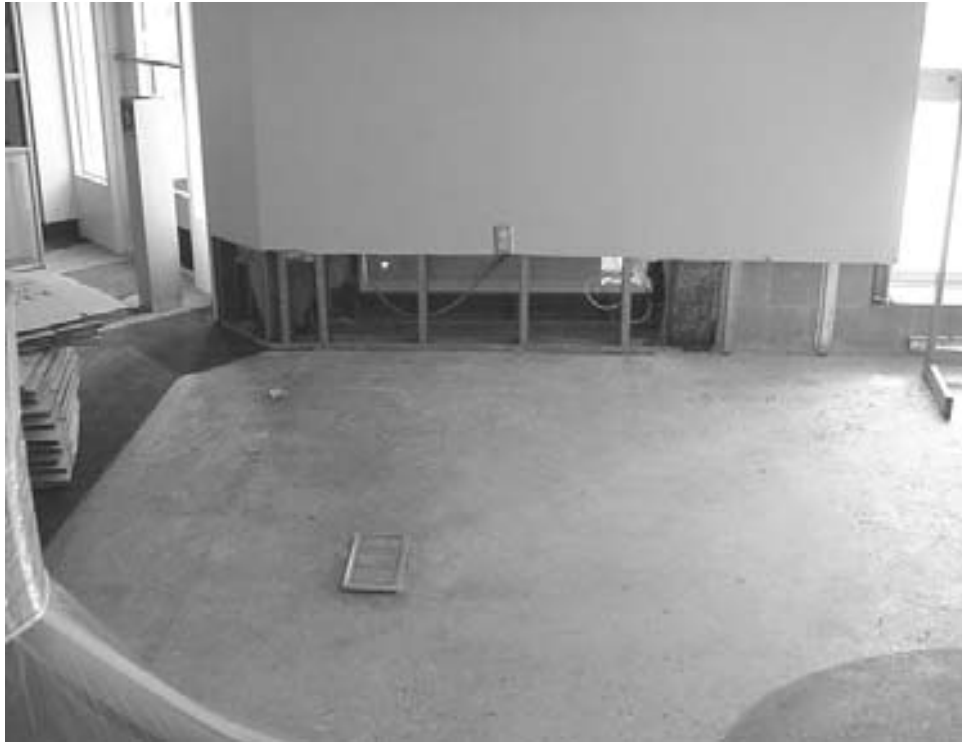
Picture 2

As discussed, the CPL had experienced water damage from the coil freezing, reportedly occurring on January 12, 2004. Remediation efforts to remove water damaged carpeting and GW were substantially completed at the time of the assessment (Pictures 2-4). GW had been removed to a height of one foot above the floor in the first floor and ground levels (Pictures 2 and 3). Carpeting in this area was removed as well.

Room Typical of Gypsum Wallboard and Carpet Removal

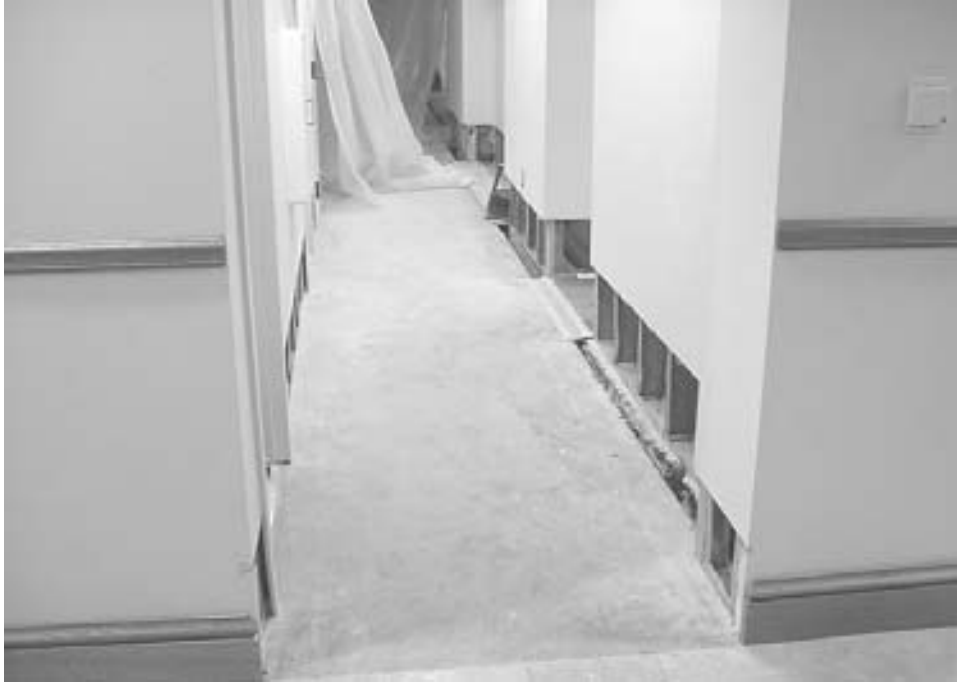
Picture 3

Hallway Typical of Gypsum Wallboard and Carpet Removal

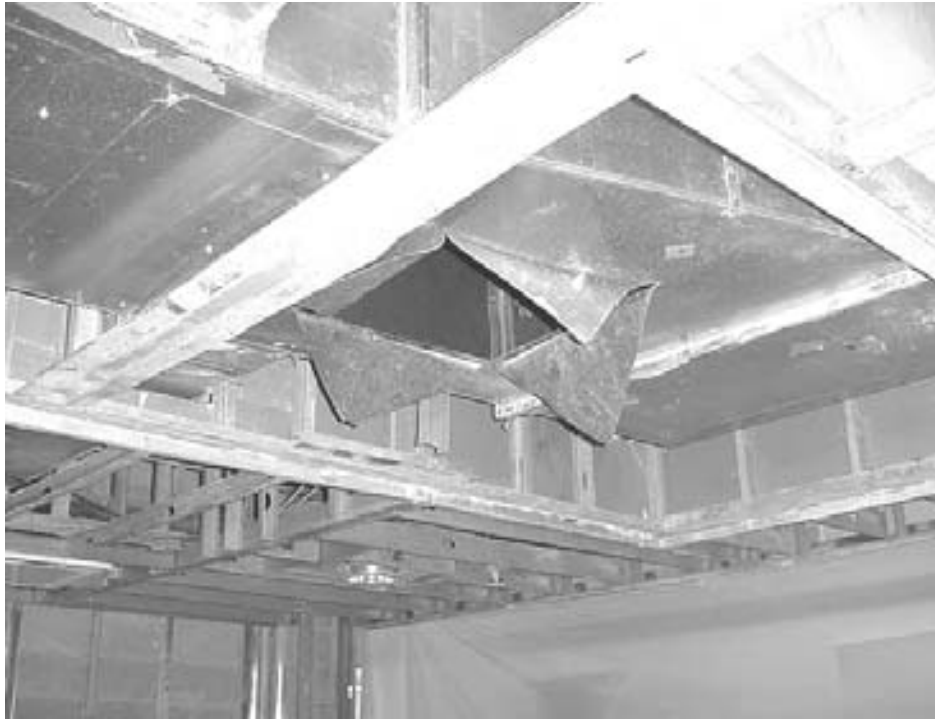
Picture 4

Examination Holes Opened in Ductwork below AHU with Frozen Coil, Note Removed Ceiling Tiles
